**CITY OF DELAWARE**  
**HISTORIC PRESERVATION COMMISSION**  
**AGENDA**  
**CITY COUNCIL CHAMBERS**  
**1 SOUTH SANDUSKY STREET**  
**7:00 P.M.**

**2016-1725:** A request by JATAK LLC for a Certificate of Appropriateness for building improvements at 18-20 West William Street which is zoned B-2 (Central Business District) and located in the Transitional Sub-district of the Downtown Historic District Overlay.

**CASE NUMBER:** 2016-1725 18-20 West William Street Building Improvements

2016-1725  
Building Improvements  
18 & 20 West William Street  
Location Map

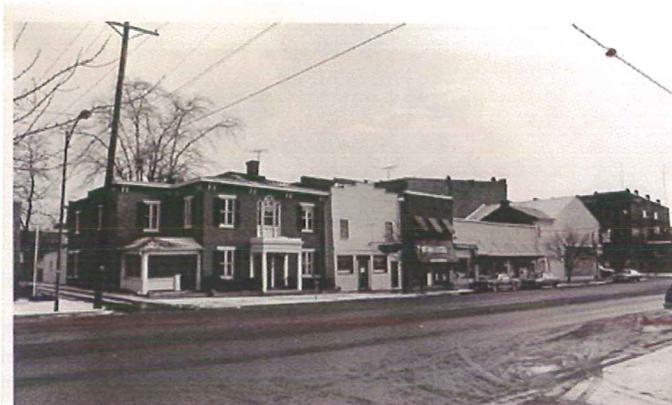
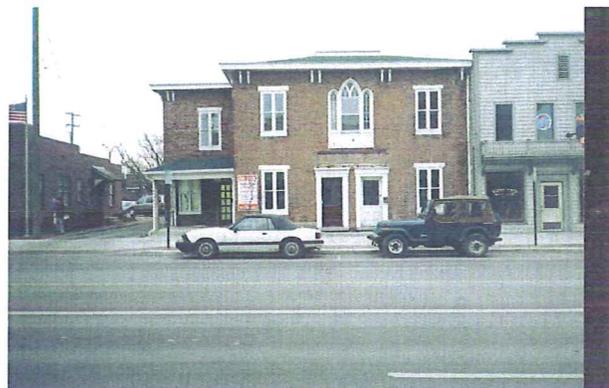
18-20 West William Street – Circa 1950s and 2001

The current Owner purchased the building in 1999 and has invested his monies in its preservation since then. He expanded his hair salon and spa services business to encompass the entire first floor area. Remnants of original wood flooring, archways, and connecting doors can still be seen. The second floor has been renovated into residential living space with new kitchen and bathroom facilities. In 2005 (HPC 2005-002), the Owner rebuilt two of the street-side side-by-side south (front) entry doors and re-instated the 2<sup>nd</sup> floor balcony and porch columns in an appropriate design to mimic what was in place at one time.

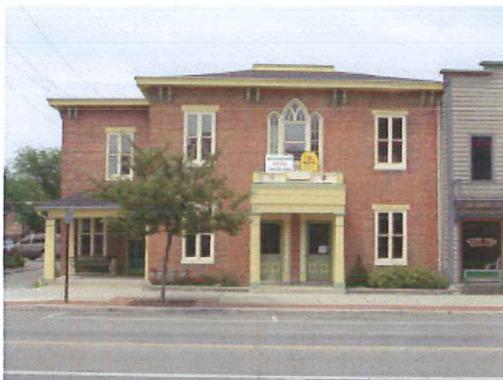
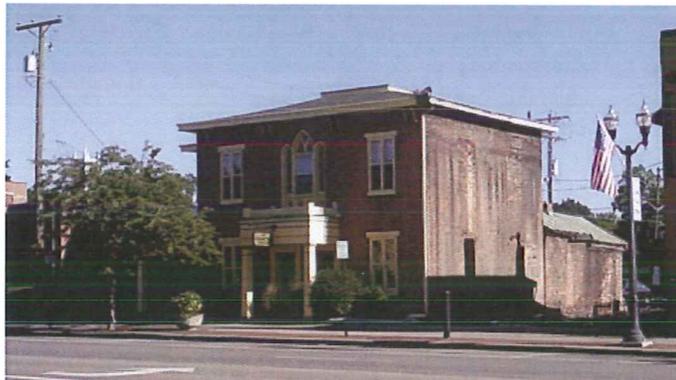
18-20 West William Street – 2005 and 2016

In 2012 (HPC 2012-2083), the Owner repaired and repainted the front porches, as well as performed extensive brick and masonry repairs on the front (south), alley-side (west), and rear (north) elevations of the building. The east (side) elevation was entombed in the late 1800s when adjacent 14 West William Street (the former West End Grill) was constructed. The adjacent buildings literally were spliced together with conjoining asphalt roofing and gutter materials. In 2013, the former West End Grill closed, and the vacant building was sold in 2014 after going to auction. It was subsequently condemned and demolished in late 2015. Consequently, the east (side) brick elevation of 18-20 West William was exposed to the elements once again after 130 years. Four (4) window openings were revealed that were apparently bricked in prior to the construction of 14 West William Street. These window openings have been walled over on the interior years ago; the windows themselves have been lost to history. Regrettably, the demolition of the vacant building has resulted in unintended damage to the now-exposed east elevation of the main building and rear brick addition of 18-20 West William Street.

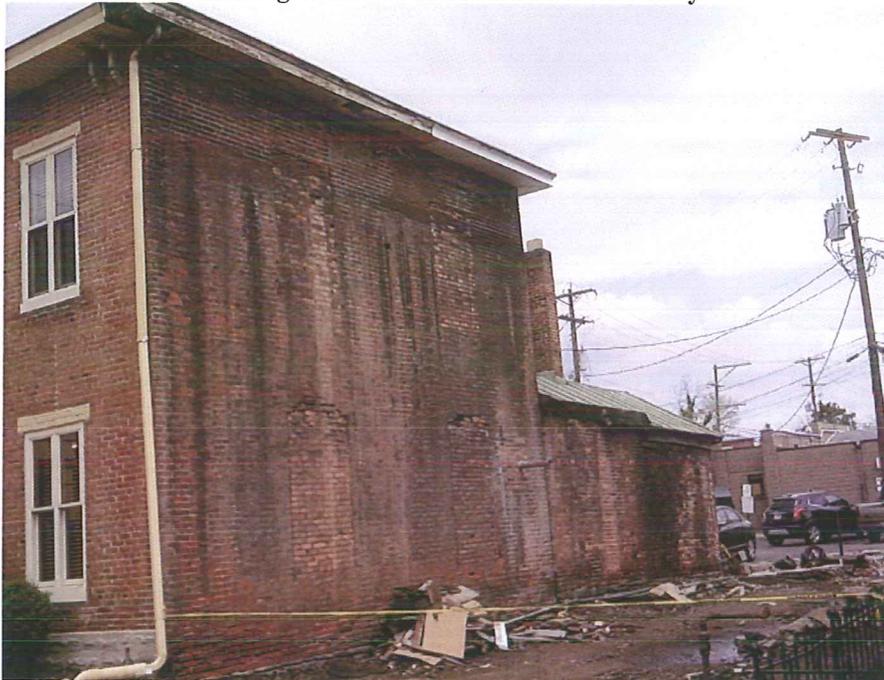
**Existing Condition East Elevation: Masonry**

- 1) East Elevation Brick and Masonry Restoration. Proposed masonry work includes brick and mortar cleaning, repair and/or replacement on the east (side) elevation of the building. The selected mason has previous experience working on National Register buildings. All work will be done according to historic masonry restoration standards per the US Department of Interior and City of Delaware Architectural Standards. The brick

and mortar will be cleaned of dirt and grime, to original color if possible, using the gentlest means possible with a mild biological cleaner so as to not remove existing brick glazing. Deteriorated mortar will be removed and replaced with historic Type O lime base mortar of texture, color, and strength to match original mortar. Broken, missing, or spalled brick will be replaced with matching historic brick. The brick in the four (4) window openings will be removed and re-laid with matching brick and contrasting (herringbone-style) brick pattern to maintain the window opening profile. In addition, the century-old stone foundation will be re-tuckpointed.

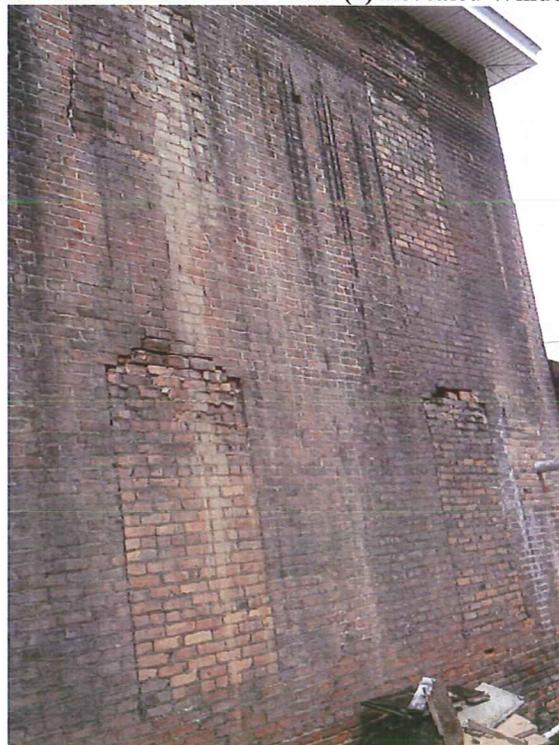
**Existing Condition East Elevation: Four (4) Revealed Window Openings**

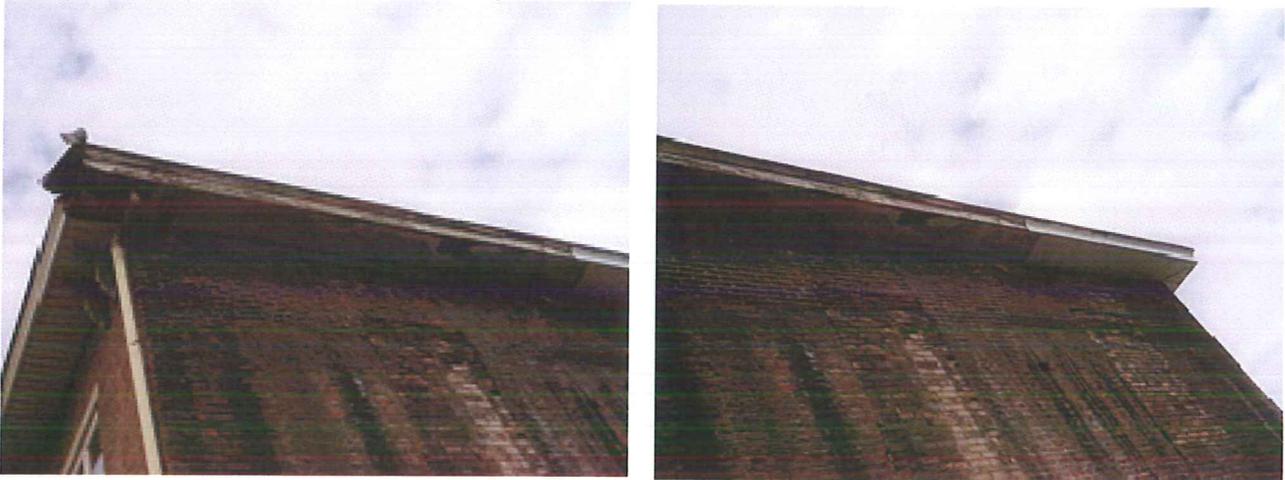
**Existing Condition East Elevation: Soffit**

2) East Elevation Second Story Soffit Repair: The rotted and damaged wood soffit will be removed and replaced with new exterior grade wood. The soffit will be re-wrapped with white aluminum fascia and vented soffit panels to match what is in place on the rest of the building. New white aluminum gutters and downspouts will eventually be installed, depending on the new building plans for the vacant lot at adjacent 14 West William Street.

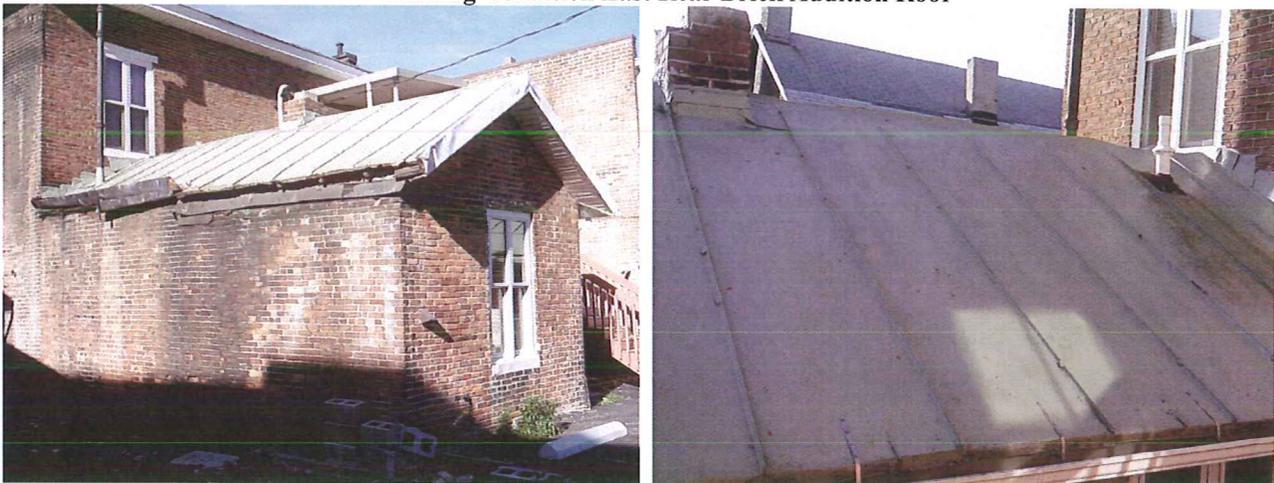
**Existing Condition East Rear Brick Addition Roof**

3) East Rear Brick Addition Roof Replacement: The leaking, rusted, and damaged metal roof will be removed and replaced with black asphalt shingles (to match the asphalt shingle on the existing mansard roof) and will be ventilated with a ridge vent. The rotted and damaged roof sheathing and wood soffit will be removed and replaced with new exterior grade wood. The soffit will be re-wrapped with white aluminum fascia and vented soffit panels to match what is in place on the rest of the building. The existing chimney was damaged during demolition of 14 West William Street and will either be removed or re-built. New aluminum gutters and downspouts will be installed on the east side of the addition, depending on the new building plans for the vacant lot at adjacent 14 West William Street. The gutters and downspouts on the west side of the addition will be reinstalled.

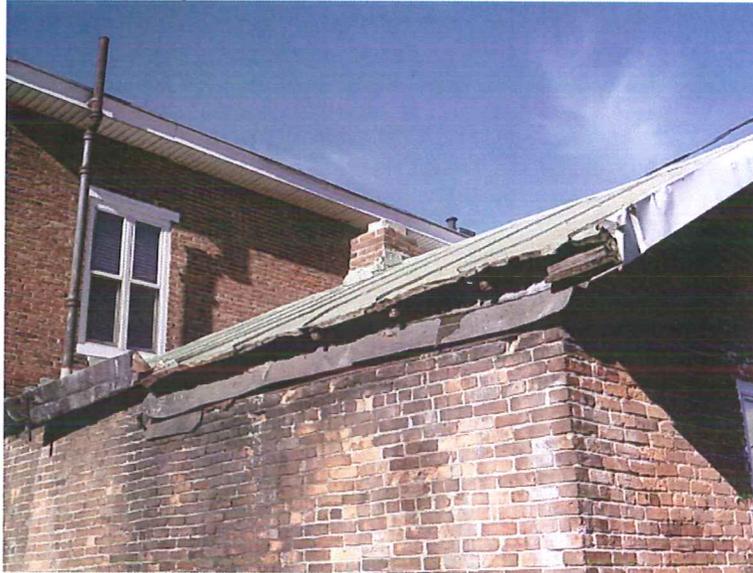
**Existing Condition East Rear Brick Addition Soffit**

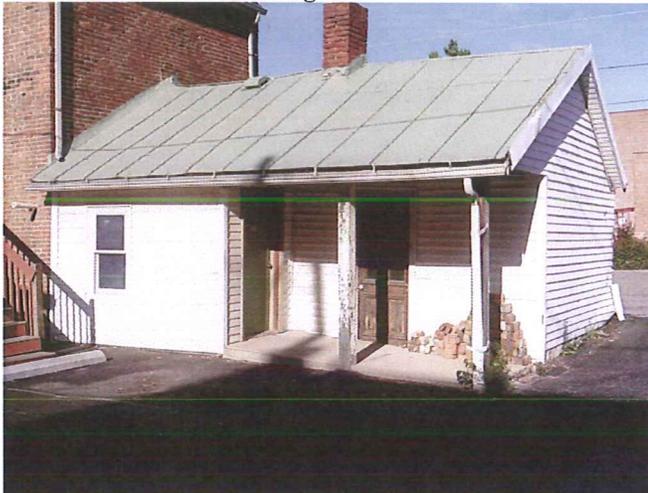
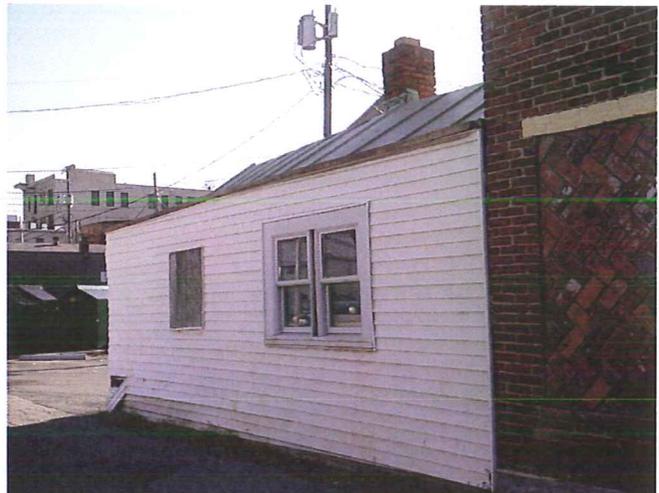
**Existing Condition West Rear Addition Extension – West and East Elevations**

4) West Rear Addition Extension Removal: The one-story 12'x12' wood frame, metal-roofed, vinyl-sided extension is obviously not original to the building and has deteriorated substantially over the years. The building has sustained much vehicular damage from those using the adjacent alley and parking lot. The Owner has made many repairs over the years, only to have the repaired addition damaged again. Due to the deteriorated and damaged condition of the structure, the Owner is proposing to demolish and remove this rear addition extension. The newly exposed north elevation of the rear brick addition will be repaired as needed (brick and mortar, downspouts, etc.) to make the rear wall sound and weathertight. The area where the addition stood will be graded and covered with asphalt for possible future parking.

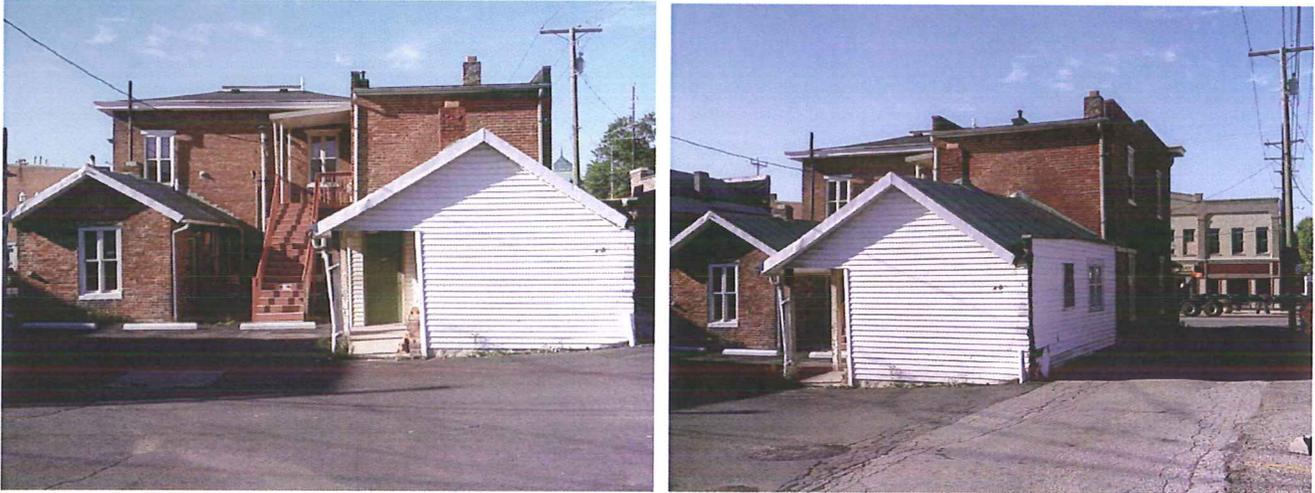
**Existing Condition West Rear Addition Extension – North Elevation**
